# **CONFIDENTIAL INSPECTION REPORT**

## **INSPECTION ADDRESS**

16755 W. Desert Bloom St., Goodyear, AZ 85338

6/13/2013 2:00 pm to 4:30 pm

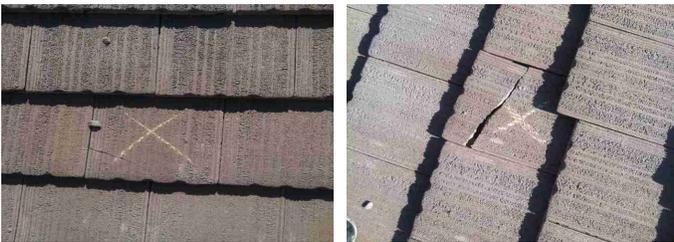
There are a number of cracked or broken tiles that have exposed the waterproof membrane, which should be serviced or the roof could leak. Noted 2 cracked roof tiles that have all been marked with a Chalked X. Please have all tiles repaired and or serviced as needed.

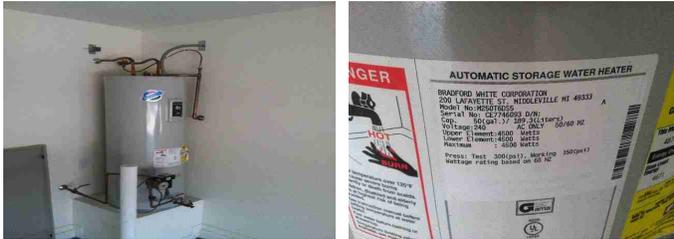
Hot water is provided by a 7 year old, 50 gallon water heater that is located in the garage. Bradford White.

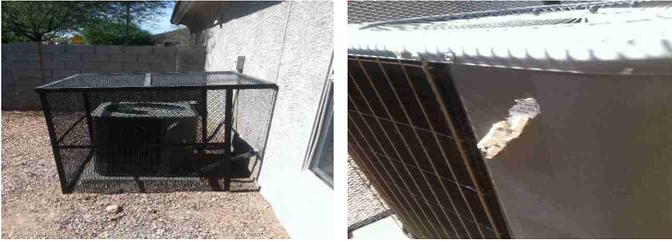
Central heat and air-conditioning are provided by a single split-system, consisting of a 7 year-old furnace with an evaporator coil that is located in the attic, and a 7 year-old condensing coil that is located on the right side wall. Unknown tonage and or year since the Lennox manufacture plate is worn and or off.

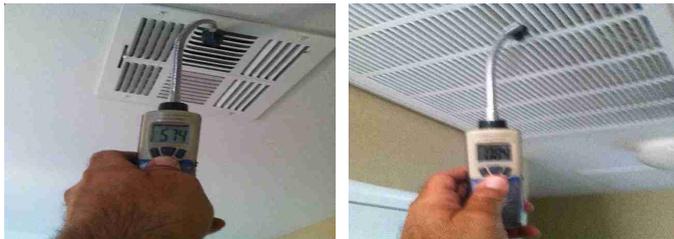
The air-conditioning responded and achieved an acceptable differential temperature split between the air entering the system and that coming out, of eighteen degrees or more. 57, 83. All rooms were checked and found to have adequate AC distribution.

We turned on the air conditioning when we arrived at the house and ran it until the end roughly 2 hours later. Therefore we tested the HVAC system for the whole 2 hours when we were at the house/residence.

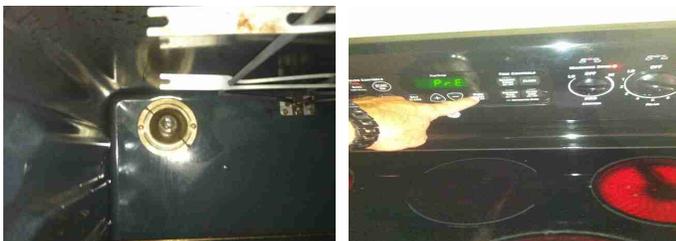
We observed the oven light is not operating.
